**US Army Corps
of Engineers.**

Shoal-Reduction Strategies for Entrance Channels

by Julie Dean Rosati and Nicholas C. Kraus

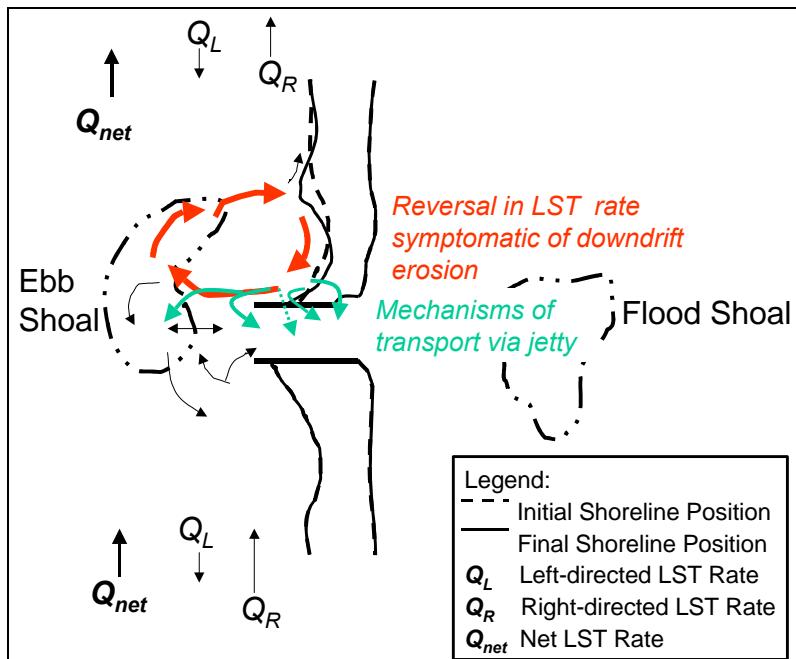
Figure 1. Schematic of longshore sand transport patterns in the vicinity of an inlet, with sediment patterns highlighted (transport via jetty (green); down-drift reversal in the net longshore sand transport (red))

Permeable jetties and jetties with elevations that are low relative to the adjacent beach can contribute to erosion of the adjacent beach and shoaling of the inlet channel (Figure 1). Jetty elevation below that of the berm elevation of the adjacent beach allows wave runup to transport sand over the top of a jetty and into the inlet, exacerbated during times of storms and high water level. This sediment-transport pathway is an unnecessary loss of material from the adjacent shoreline, and increases shoaling of the entrance channel. This loss is especially detrimental for down-drift beaches, which tend to lose sand because of a near persistent local transport reversal. As an example of this phenomenon, consider Ocean City Inlet, Maryland (Figures 4a, 4b, and 4c).

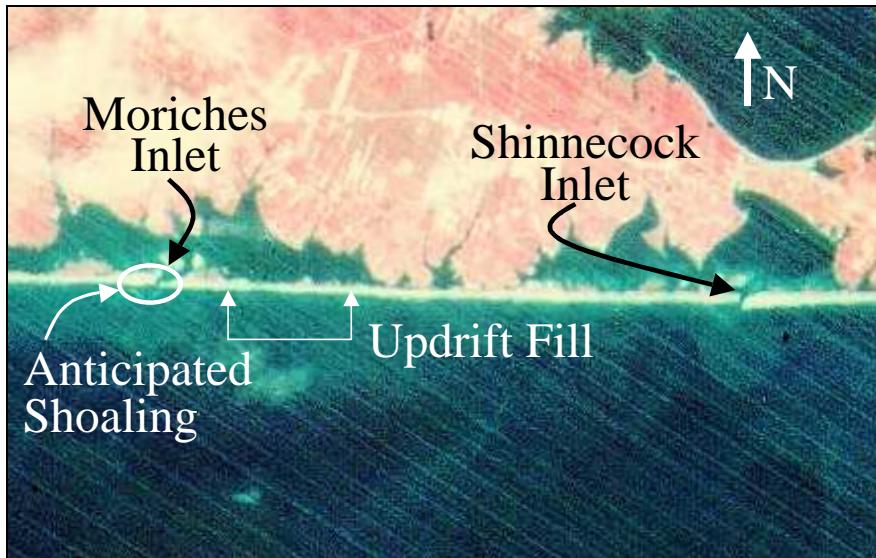
manner. A prototype example of this situation is Moriches Inlet, New York. From 3.2 to 8.6 km updrift of Moriches Inlet, beach fill totaling 2.9 million m³ was placed during 1996-1997, and renourishment is planned on 3- to 6-year intervals for 27 years, averaging 288,000 m³/yr (Figure 2).

Figure 2. Location of beach fill placed updrift of Moriches Inlet, New York

Considering a regional scale of coastal processes, this beach fill material will be transported towards Moriches Inlet in the net (westerly) direction of longshore sediment transport. As a conservative estimate, it could be assumed that shoaling in the inlet would increase by the renourishment rate, roughly 288,000 m³/yr. A proactive dredging plan will include budgeting for this possible increase in the out-year Operation and Maintenance schedule, as well as monitoring the shoaling rate and region of deposition, and modifying the plan as appropriate.

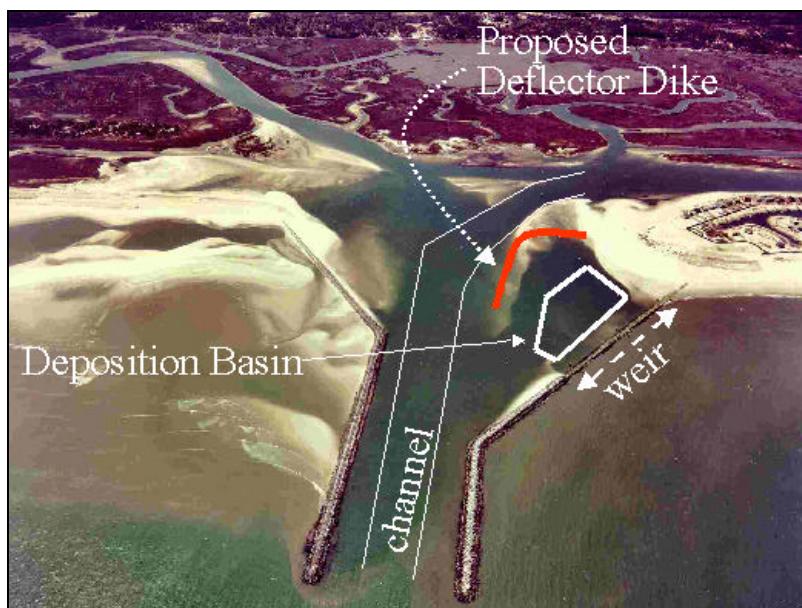
Figure 3. Murrell's Inlet, South Carolina showing weir jetty, deposition basin, and spit formation encroaching channel
(photograph dated 7 April 1982)

Results of a 9-year monitoring program indicated that sediment tended to transport over and through the weir jetty, as designed. However, sediment then bypassed the deposition basin,

forming a spit that encroached the navigation channel (Douglass 1987, Figure 3). It is likely that the proposed deflector dike would have retained sediment in the deposition basin.

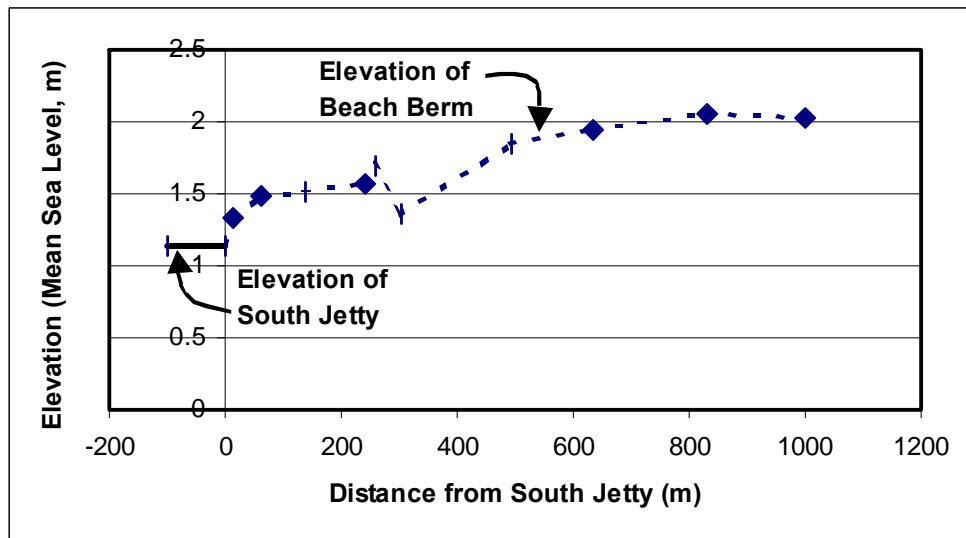
Figure 4b shows the elevation of the berm adjacent to the south jetty, indicating an increase in this elevation with distance from the south jetty. Because the jetty was lower than the adjacent beach berm, a downhill gradient existed from the beach towards the jetty. The downhill gradient in beach elevation allowed the flow of water and sand over and through the south jetty.

Figure 4b. Increase in beach berm elevation with distance from Ocean City Inlet pre-rehabilitated south jetty (based on March 1976 profile data of Dean, Perlin, and Dally (1978))

In 1985, a new south jetty section was constructed, offset 10 m south of the existing jetty centerline (Bass, Fulford, and Underwood 1994). The new section had a crest elevation 3.3 m relative to mean sea level (msl) (former jetty crest was 1.2 m msl), and was constructed with an impermeable core wall composed of precast concrete units. In addition, three headland breakwaters were constructed on the southern bank of the inner inlet shoreline. It was anticipated that this shoreline would erode because of elimination of the sand supply to this region. Scour at the foundation of the south jetty was also repaired. Figure 4c shows the rehabilitated construction.

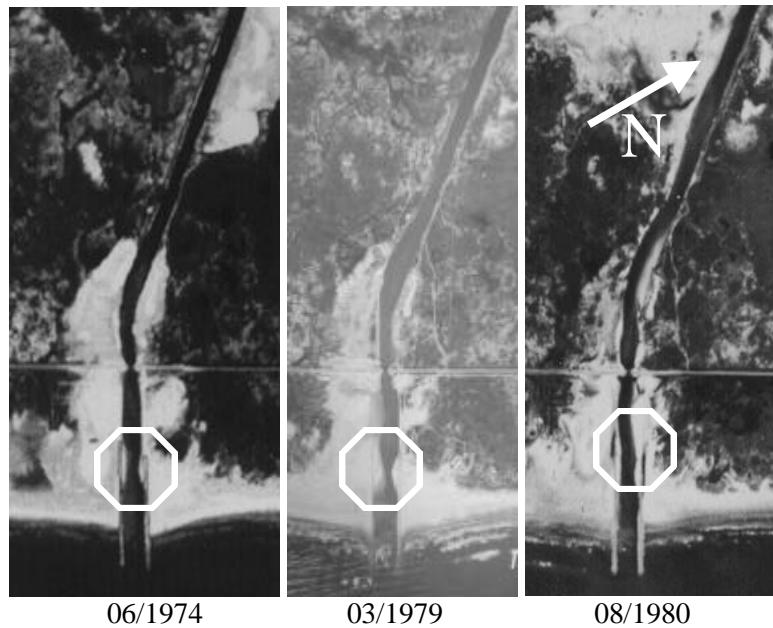
The Mustang Island Fish Pass was a 3.2-km-long channel dredged and opened in August 1972 by the Texas Parks and Wildlife Department to increase water exchange and fish migration between Corpus Christi Bay and the Gulf of Mexico. It was never a Federal channel and was not maintained once opened. The jetty spacing was 122 m, and the length (measured from the initial shoreline) into the Gulf was 260 m (Behrens and Watson 1977, Kraus and Heilman 1997). By March 1985, the pass had closed, primarily by shoaling near the Gulf entrance. Figure 5 shows areas of shoaling on three dates. Tropical storms tended to open the pass, but the strong and persistent wind blowing on the south Texas coast contributed to formation of the shoals. As described previously, raising of jetties will reduce overtopping by water carrying sand during times of high water. Similarly, higher jetty elevation and amenities such as walkways and railings that increase effective elevation will reduce overtopping by wind-blown sand. At the base of jetties, far from the beach, sand fencing and planting of vegetation can also reduce infiltration by wind-blown sand.

Figure 5. Entrance to Mustang Island Fish Pass, Texas
